A Record of the Australian Mirage Wing Fatigue Test

R. Krieser and L. Molent

DSTO-TR-1561

ABSTRACT

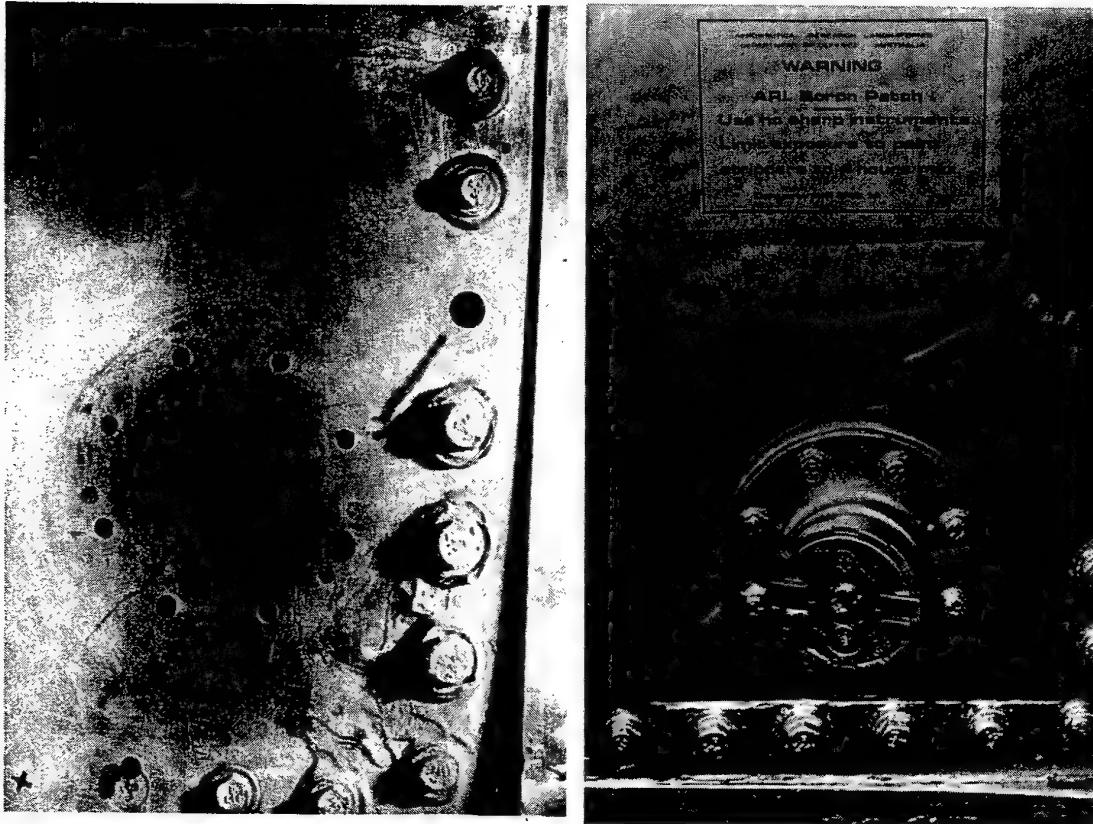
Figure 25: In-service Cracked Mirage Lower Wing Panel before and after Boron/epoxy Patching (see Figure 26 for equivalent test failure details)

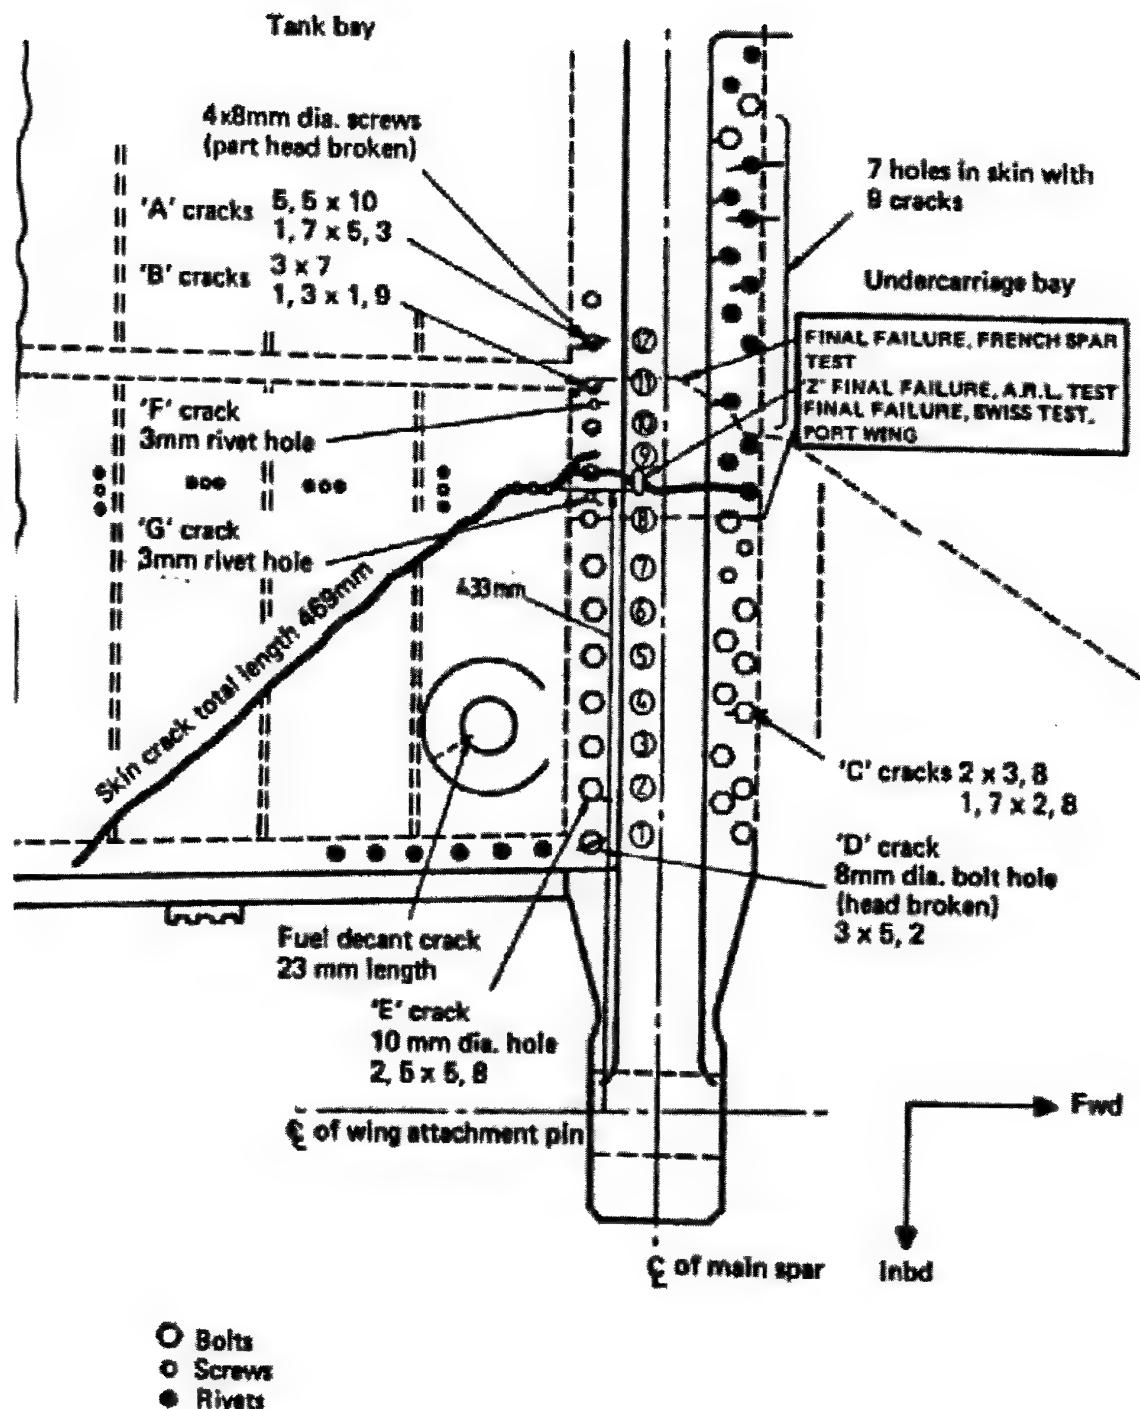
Final failure and collapse of the wing occurred after 32,372 flights (31,230 simulated test flights plus 1,142 pre-test equivalent flights) at the blind hole in the lower boom of the main spar (Figure 27 and Figure 28) 433 mm from the centre of the main spar attachment holes. It occurred unexpectedly under a load of 7.8g, during flight 65, load case 7, which simulated air combat tactics mission. This load, whilst not the highest in g value, did produce the greatest bending moment in the spar because of the aircraft loading conditions. The calculated nominal stress at this load was 151 MPa (21,800 p.s.i.). This cracking was not subsequently detected in-service aircraft (probably due to the earlier cracking in the anchor nut rivet holes).

Figure 26: Failure Locations in Starboard Mirage Wing Viewed from Lower Surface

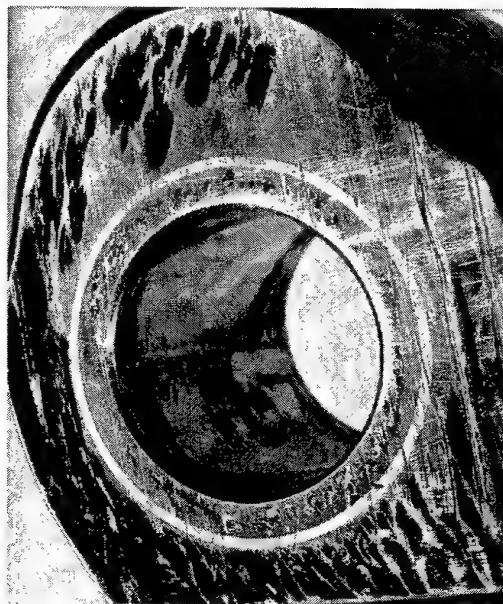
Figure 35: Lower Hole, Forward Face after Completion of Test
